VAPOR LOCK CAUSE AND CURE

The following information has been compiled from extensive research and testing performed by Chevrolet Engineering and RV manufacturers concerning fuel handling problems of the Class A Motor Home (during 1982 and 1983). Chevrolet and the RV manufacturers examined typical "problem units" furnished by various owners in order to better understand "real-world" vapor lock problems in the highly customized Class A Motor Home and develop corrective actions.

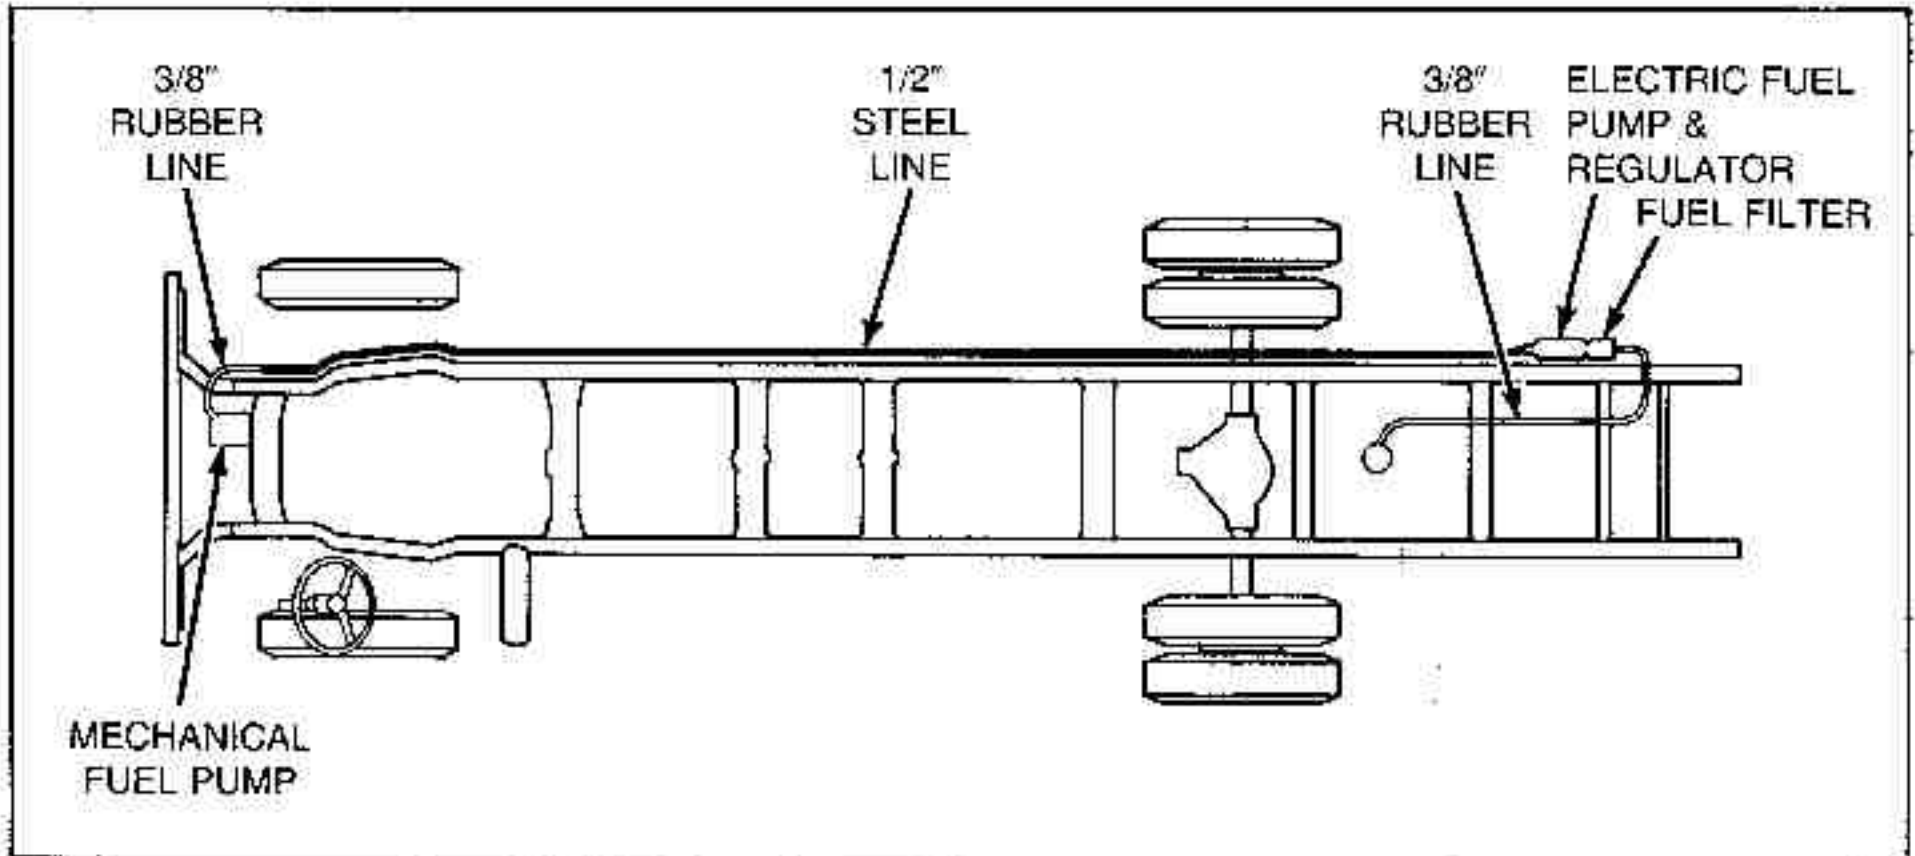
Figure A7-7-2 — 1984 Recommended Field Fix

- Four feet of rubber hose added in the middle of the stretch chassis.
- A length of hose positioned over the top of the tank to the pickup.
- Total rubber plumbing which is tied to the rear hot water lines with zip straps so that there was a tendency for the fuel to boil and the lines to "suck shut" or kink at each zip strap.
- Vehicles equipped with a defective switch valve so that the ports did not line up properly and some of the valves would only switch occasionally. (Ports that did not line up caused restriction as did units that had two additional fuel filters and a stretch chassis. All of these factors add to the load on the mechanical fuel pump.)
- An electric fuel pump installed in the return line rather than the suction line.
- Incorrect tank cap venting.
- And so on.

Chevrolet and the RV manufacturers' representatives determined that 100 percent of the motor homes produced with plumbing errors such as those above could have vapor locking problems. Investigation showed that a properly plumbed fuel system down the inside of the frame rail was also not a 100 percent cure for the problem.

- A one-half inch steel fuel line mounted on the outside of the frame rail, protected against rub and chafe (see Figure A7-7-2).

- An electric fuel pump mounted off the frame at the tank using an adjustable regulator set to 5 PSI at engine idle measured at the mechanical pump inlet (see Figure A7-7-2). Best success was obtained with the Holley Fuel Pump (No. 12-802) that includes a regulator and has ample volume for this engine (see Figure A7-7-3).

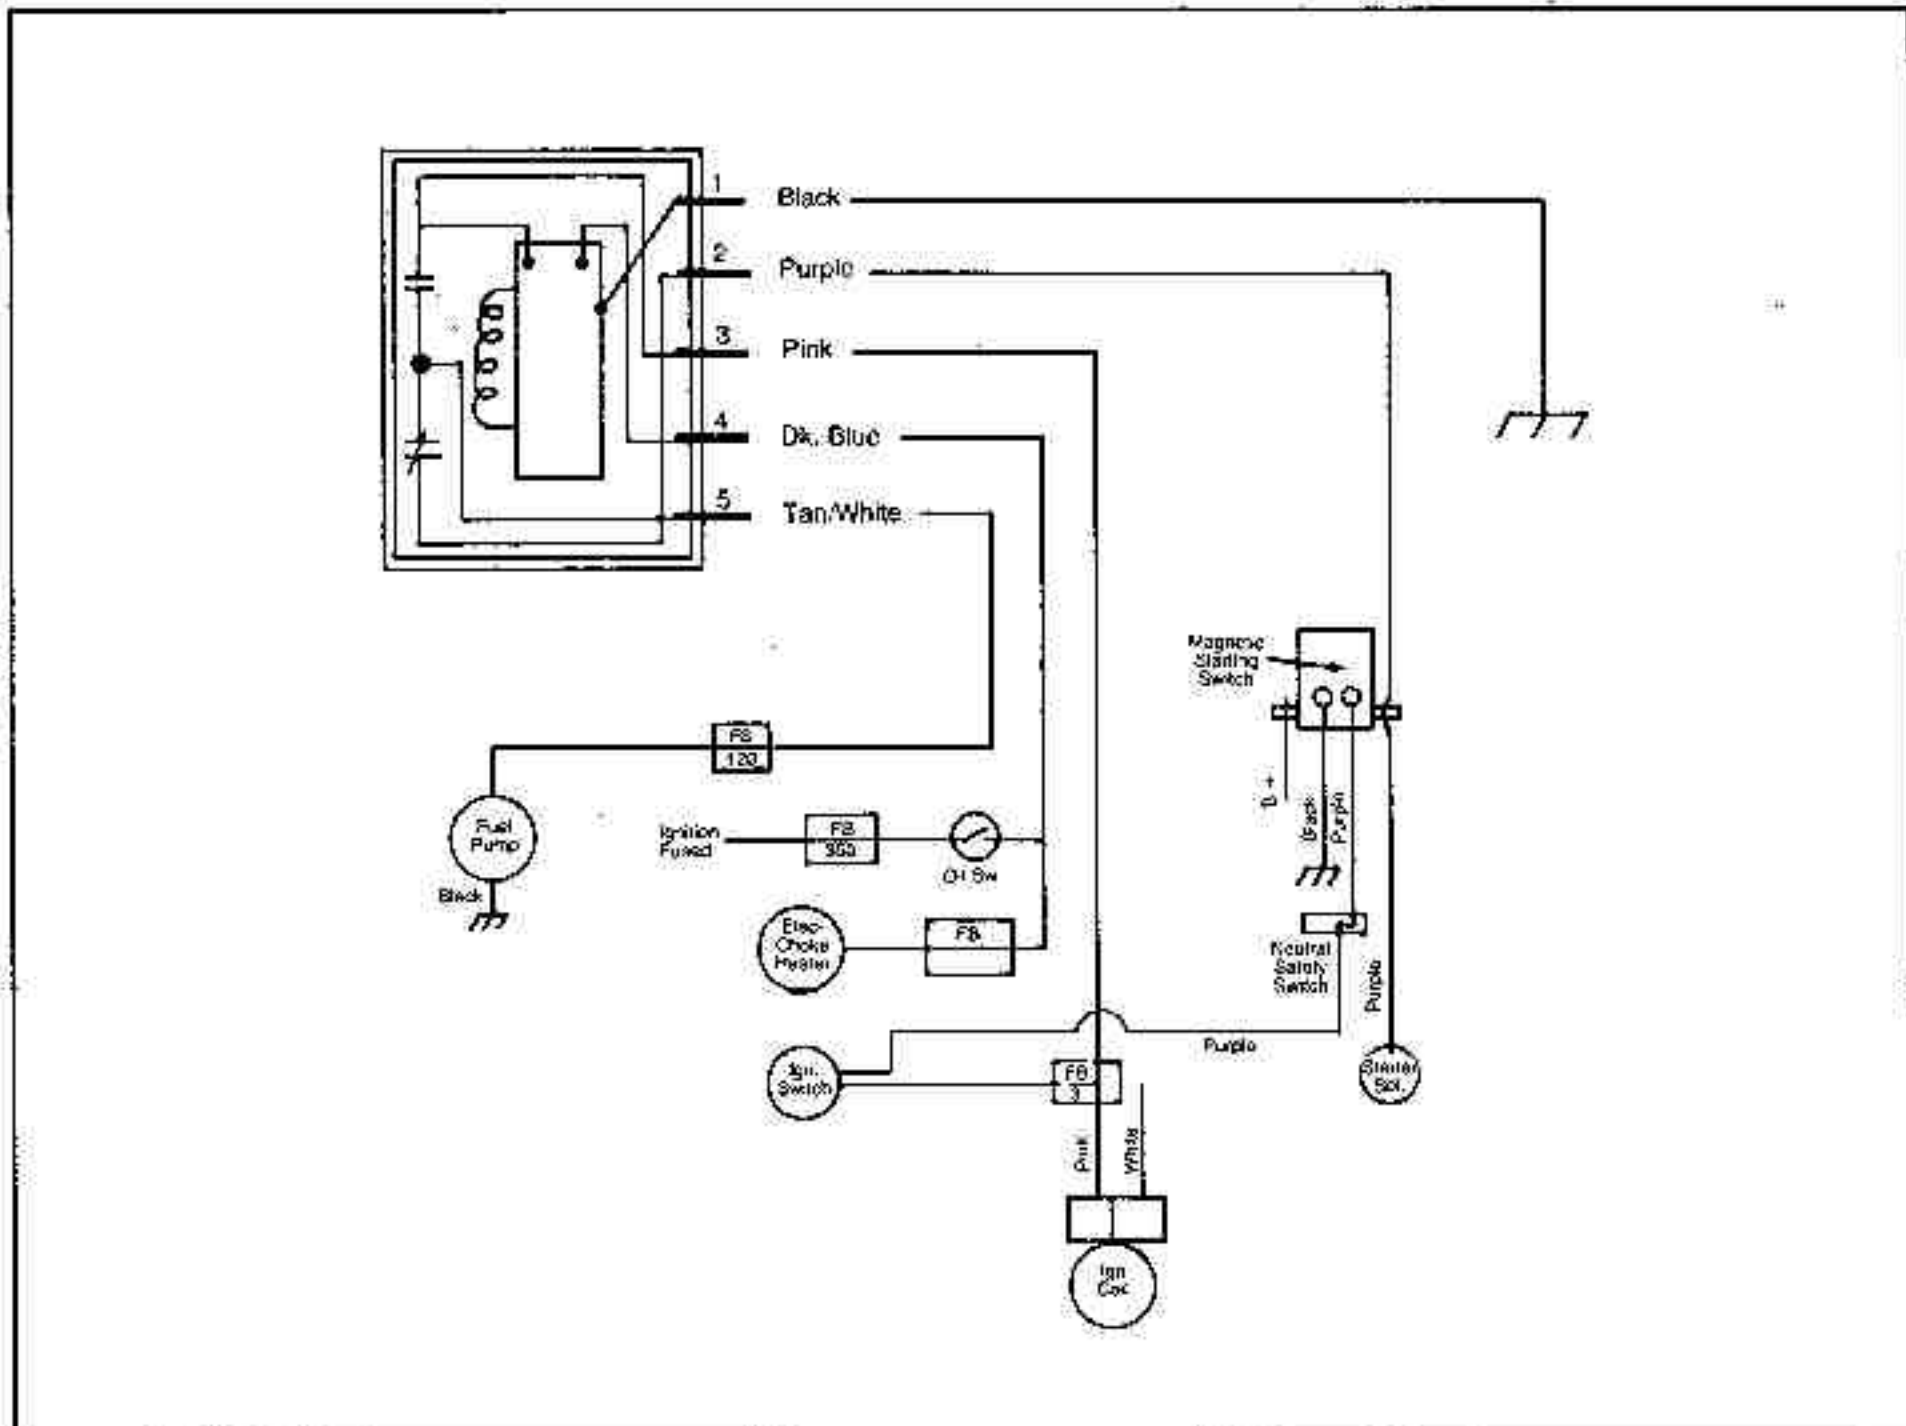
Figure A7-7-6 — Engine Electrical Fuel Pump Relay — Typical Wiring Diagram

NOTE: Without activation of the electric in-tank fuel pump, the chances for a vapor lock in the system increases because of the increased workload on the mechanical pump through the electric pump. To check the system, perform the following operational test. Turn the ignition key to the RUN position. Have an assistant check (listen/feel) the tank end for pump operation as a capacitor charges in the relay. The pump will run for approximately five seconds after the key has been turned. (Twelve volts is also supplied to the pump in the crank position and as the engine starts and oil pressure builds, 12 volts is supplied to the electric fuel pump whenever the engine is running.)

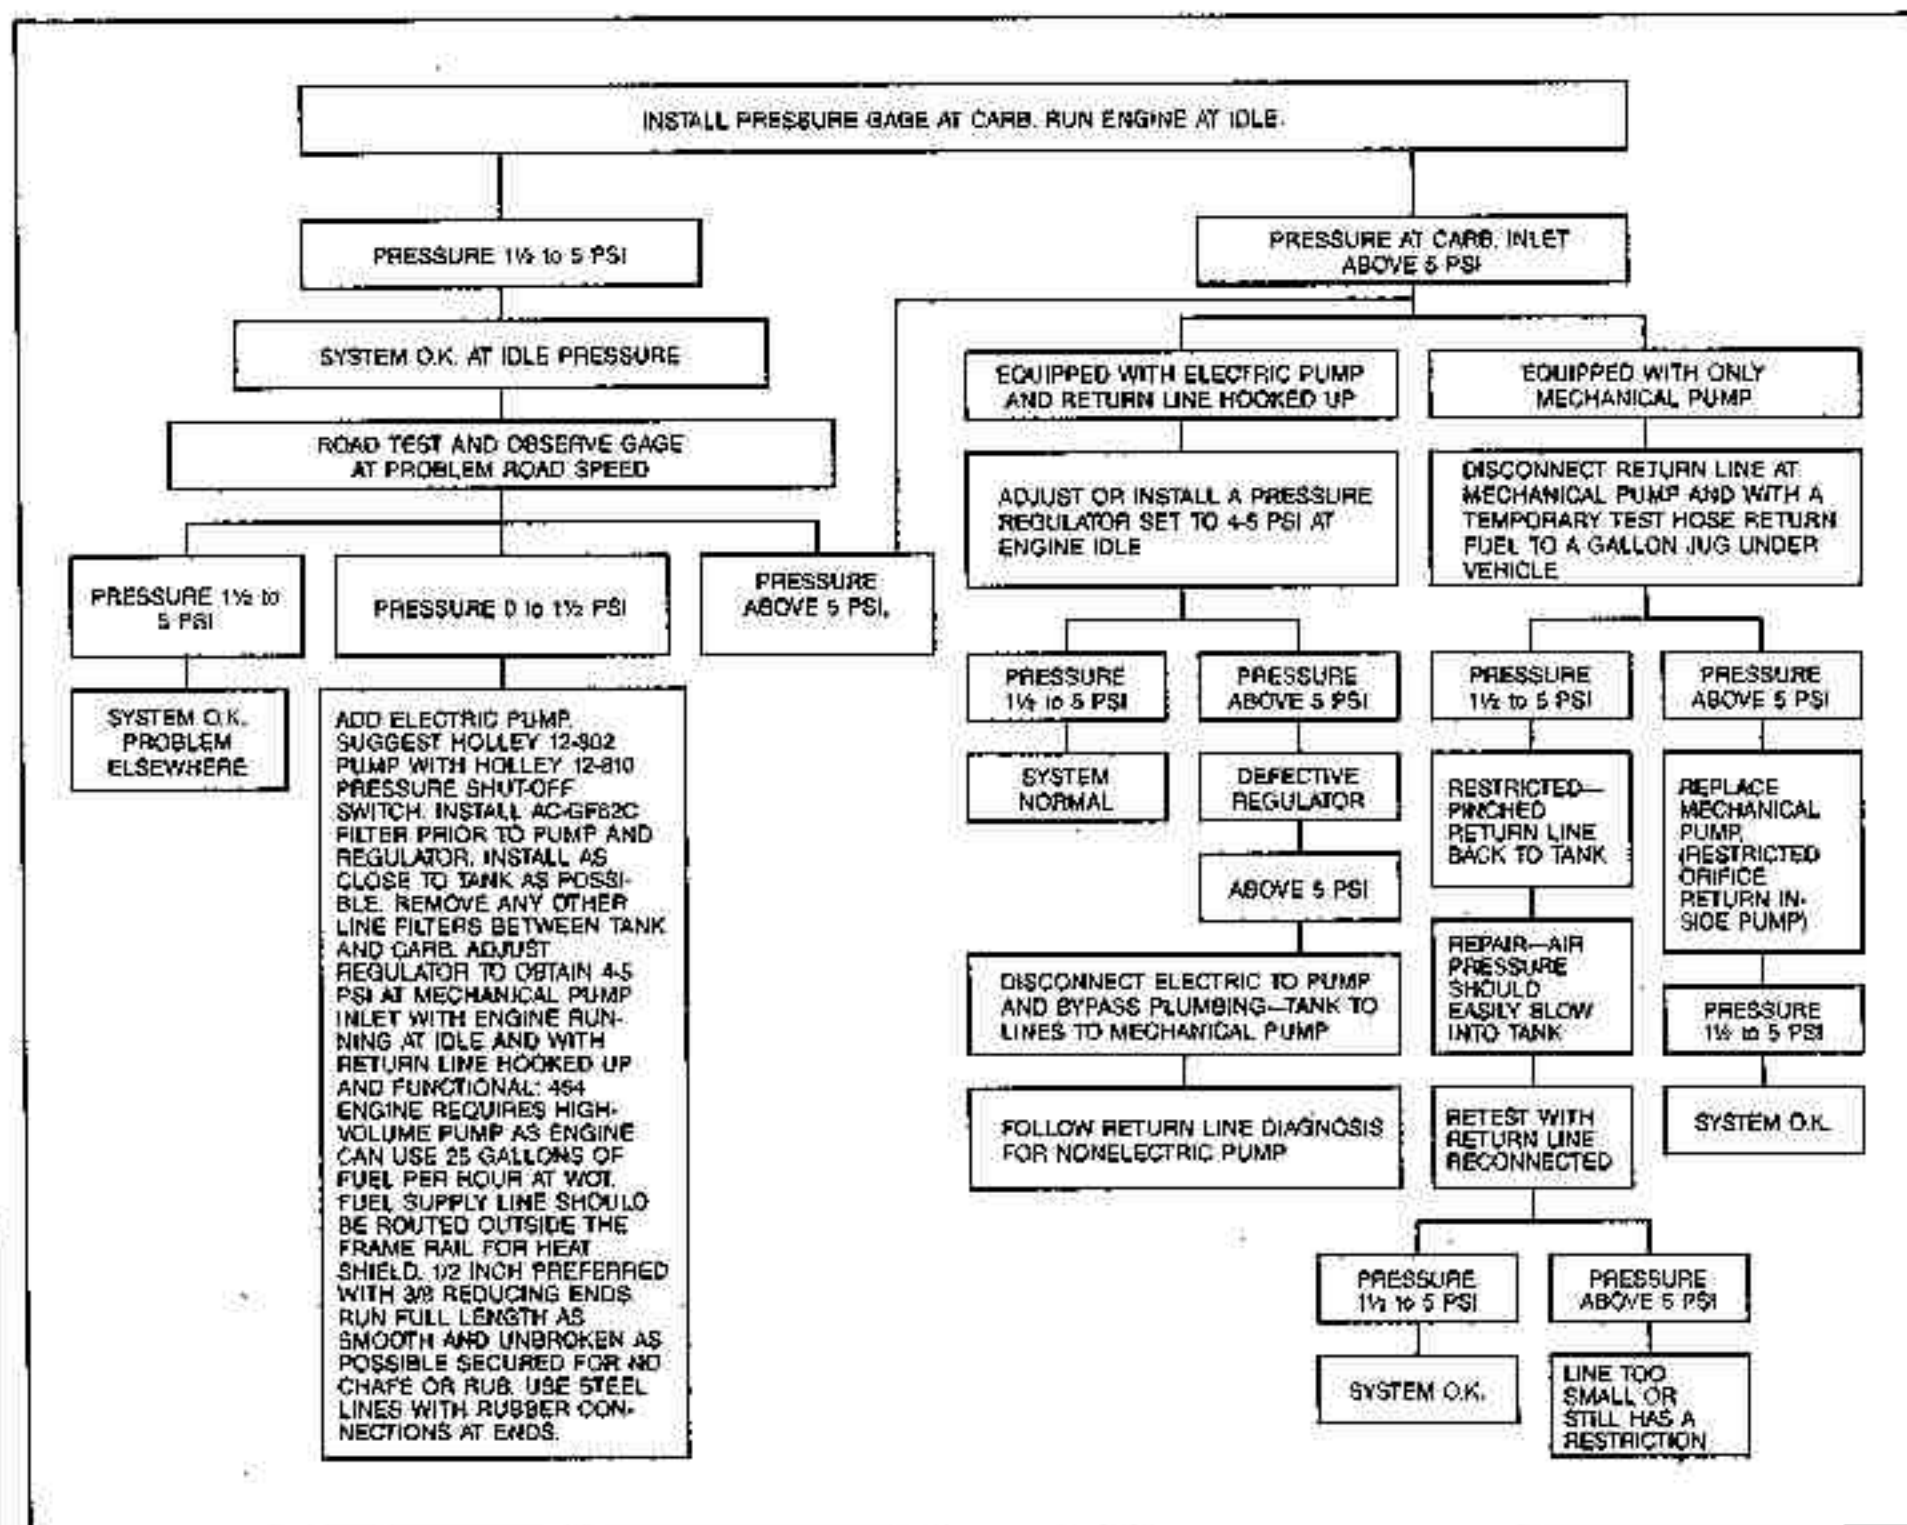
Figure A7-7-7 — Pressurized Fuel System Diagnosis Chart

- The fuel requirements for the 454 engine at wide-open throttle are 25 gallons per hour at 2 PSI minimum and 3 PSI maximum. If fuel line lengths or routings create a situation where this cannot be met, an electric pump should be added at the fuel tank to supply fuel to the mechanical pump on the engine. Pressure in the supply line will further reduce the chance of bubbles forming versus a negative pressure situation with a mechanical pump only. (See Pressurized Fuel System Diagnosis Chart in Figure A7-7-7.)
