GM Splash Shield Template and Tech Sheet

P-Series Splash Shield RH 15983041

EXHAUST MANIFOLD AND PLUG WIRE FAILURE

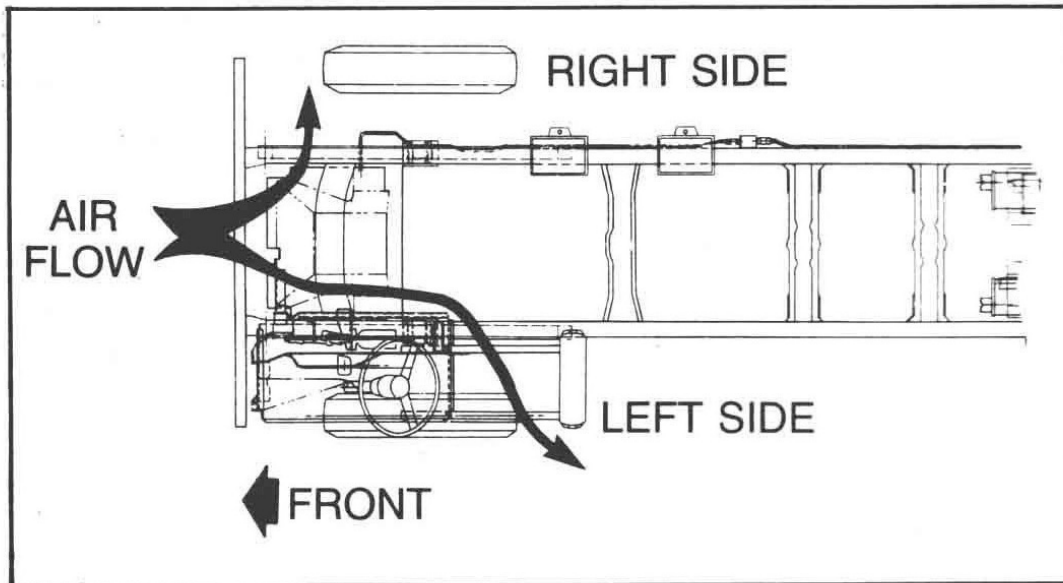
Chevrolet has determined that right side exhaust manifold and right side spark plug wire failure may be the result of inadequate air flow. This is due to the absence of a wheel-well panel on the right front wheel opening. This situation allows necessary engine cooling air flow to exit the engine compartment prior to passing the exhaust manifold and spark plug wires and thereby cooling the manifold and spark plug wires as occurs on the left side of the engine compartment.

Inadequate Engine Compartment Air Flow

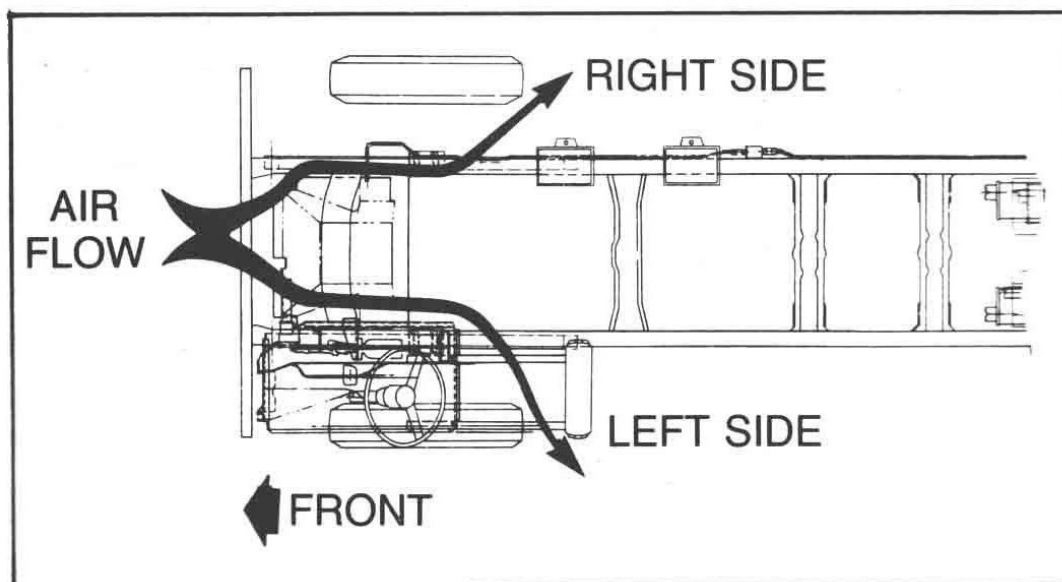
Corrected Engine Compartment Air Flow

This condition can be corrected by fabricating a metal panel similar to the one used on the left side of the vehicle. Adding the panel forces the air flow to pass along the right side of the engine compartment thereby providing a cooling effect and greatly extends the manifold and spark plug wire life.

Care must be taken in the design of the right side panel as to provide proper clearances around any hoses, wires and engine dress items and also to provide clearance for the tire throughout its movements. The panel should extend rearward to a point parallel to the number seven spark plug wire. The panel should be shaped and positioned similarly to the left side panel currently installed on the vehicle. Care must be taken to leave an opening at the rear of the engine compartment to allow cooling air to exit the engine compartment as on the left side panel.
