VAPOR LOCK CAUSE AND CURE

This information is presented as an aid to the motor home owner in understanding the problems associated with vapor lock and their suggested solutions.

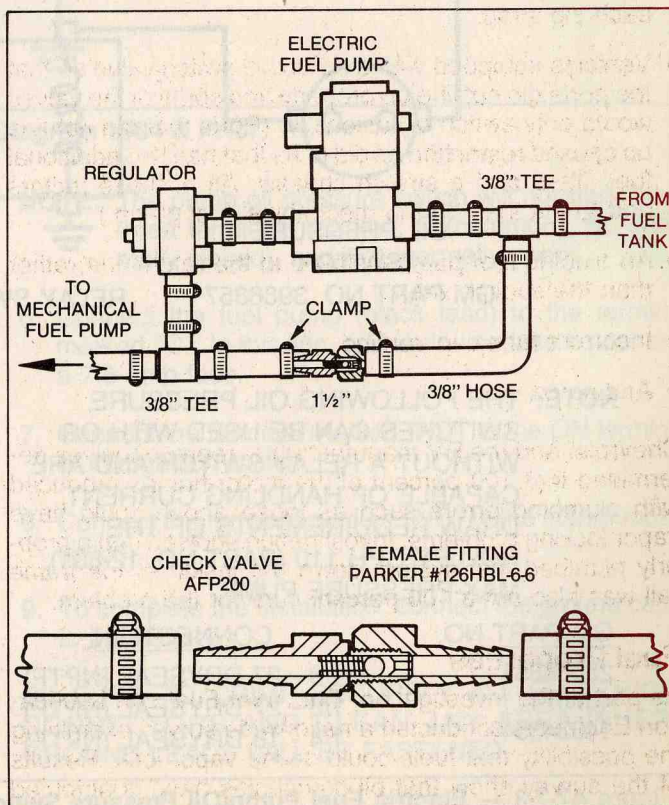
- Install one 3/8" T-fitting in the fuel line between the regulator and the mechanical fuel pump and one 3/8" T-fitting between the electric fuel pump and the fuel tank.
- Connect a 3/8" hose to the T's.
- If the bypass fuel line is already in place, remove 1-1/2 inches of 3/8 fuel line and insert check valve.
- Insert valve side in line toward mechanical fuel pump; insert fitting side into line from fuel tank.
- Secure bypass line and valve with 3/8" hose clamps.

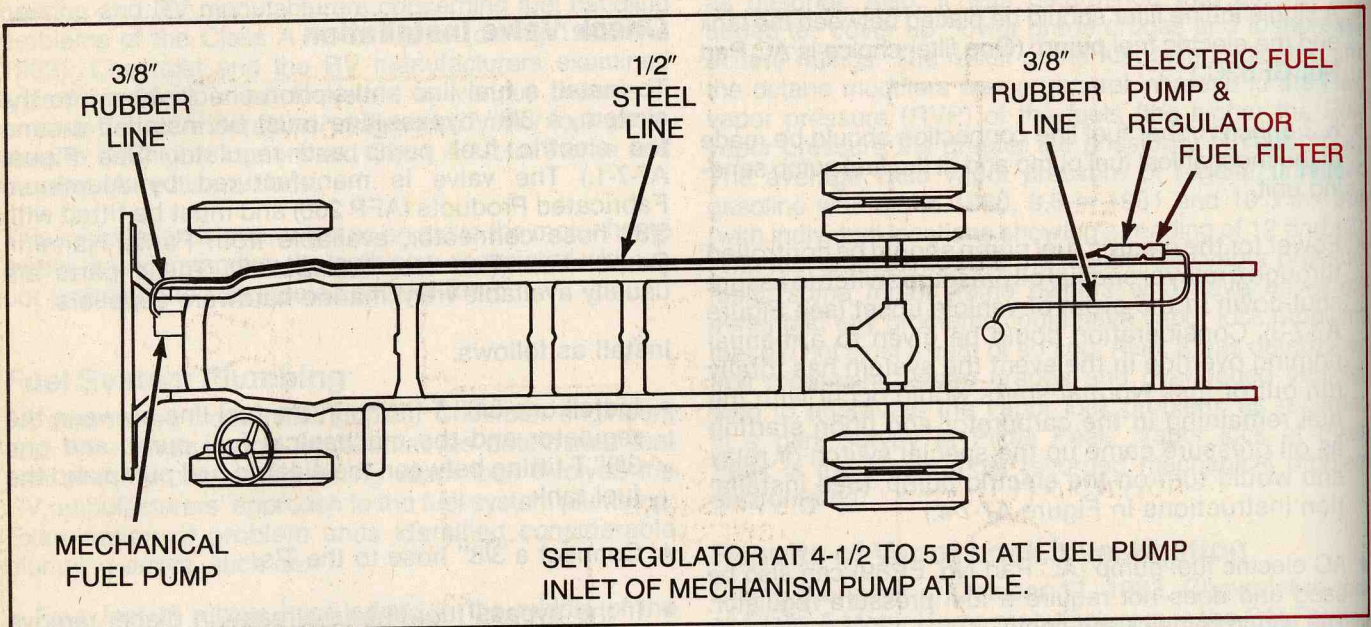
Figure A7-7-2 — 1984 Recommended Field Fix

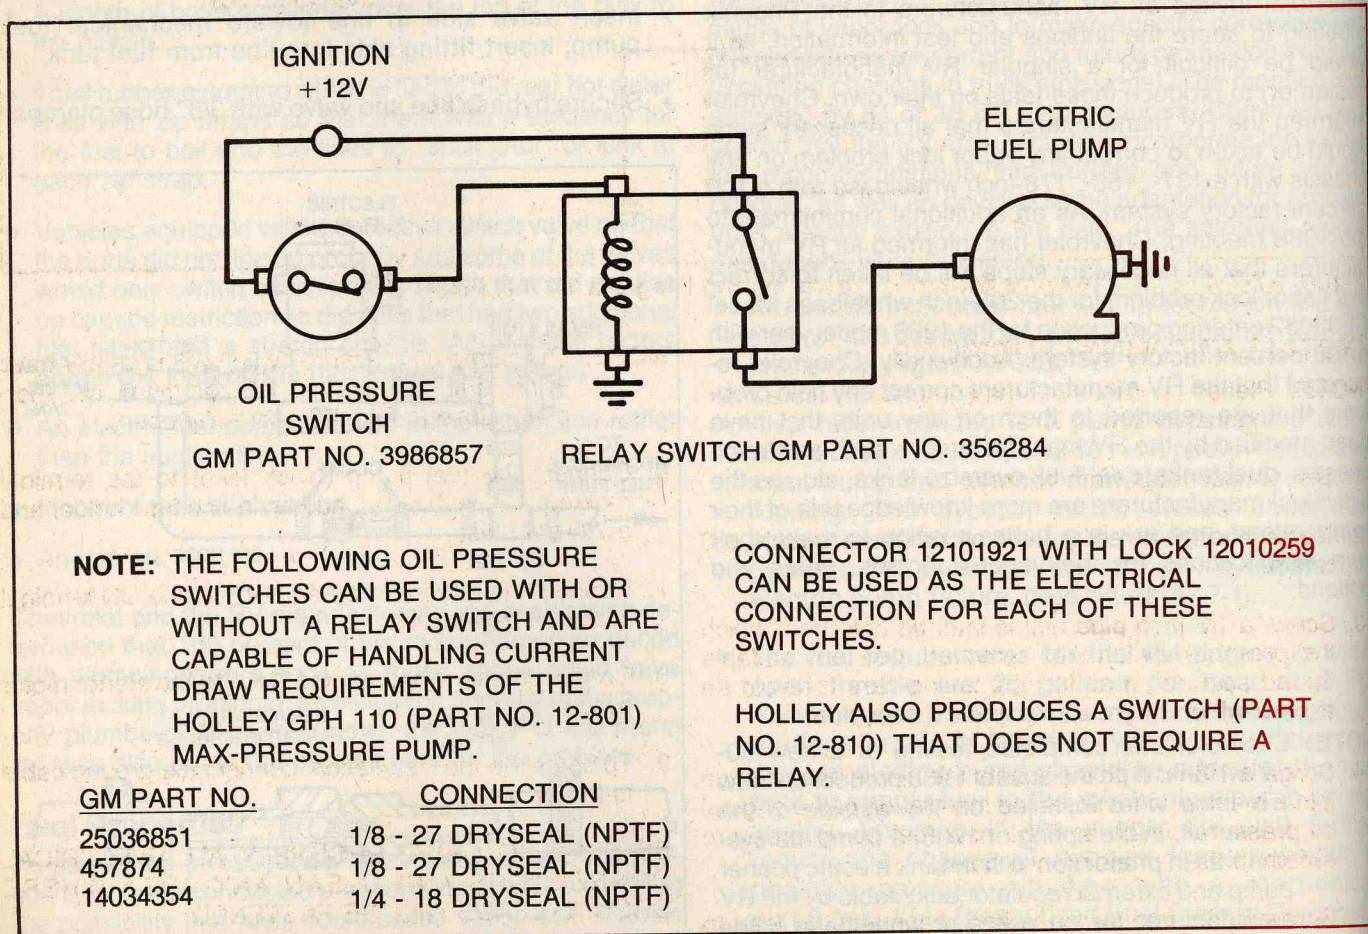
Figure A7-7-3 — Electric Fuel Pump/Oil Pressure Switch Relay

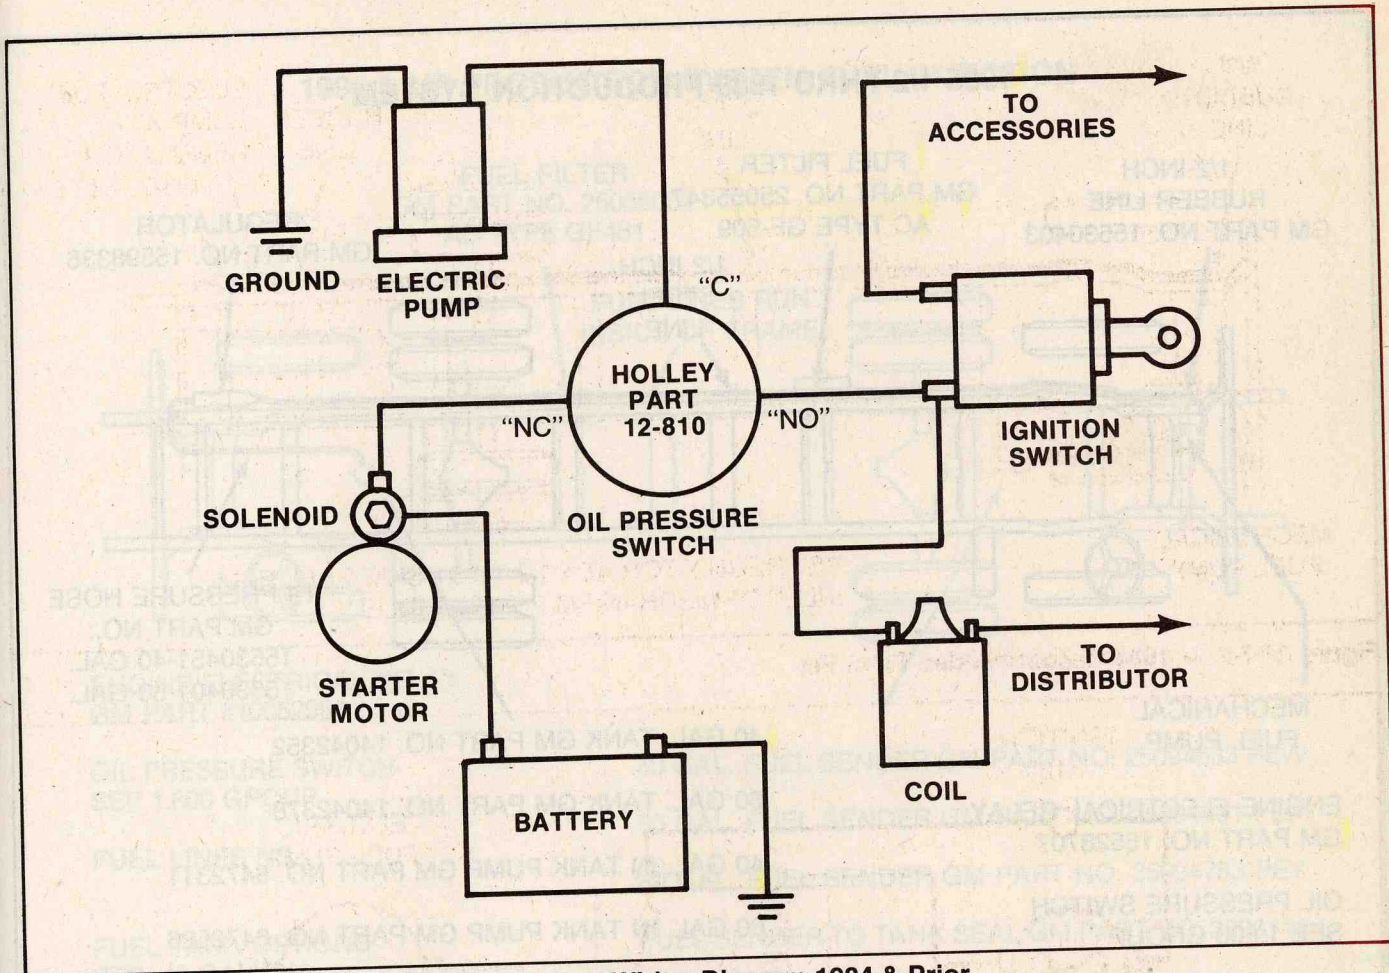
Figure A7-7-4 — Oil Pressure Switch – Typical Wiring Diagram 1984 & Prior

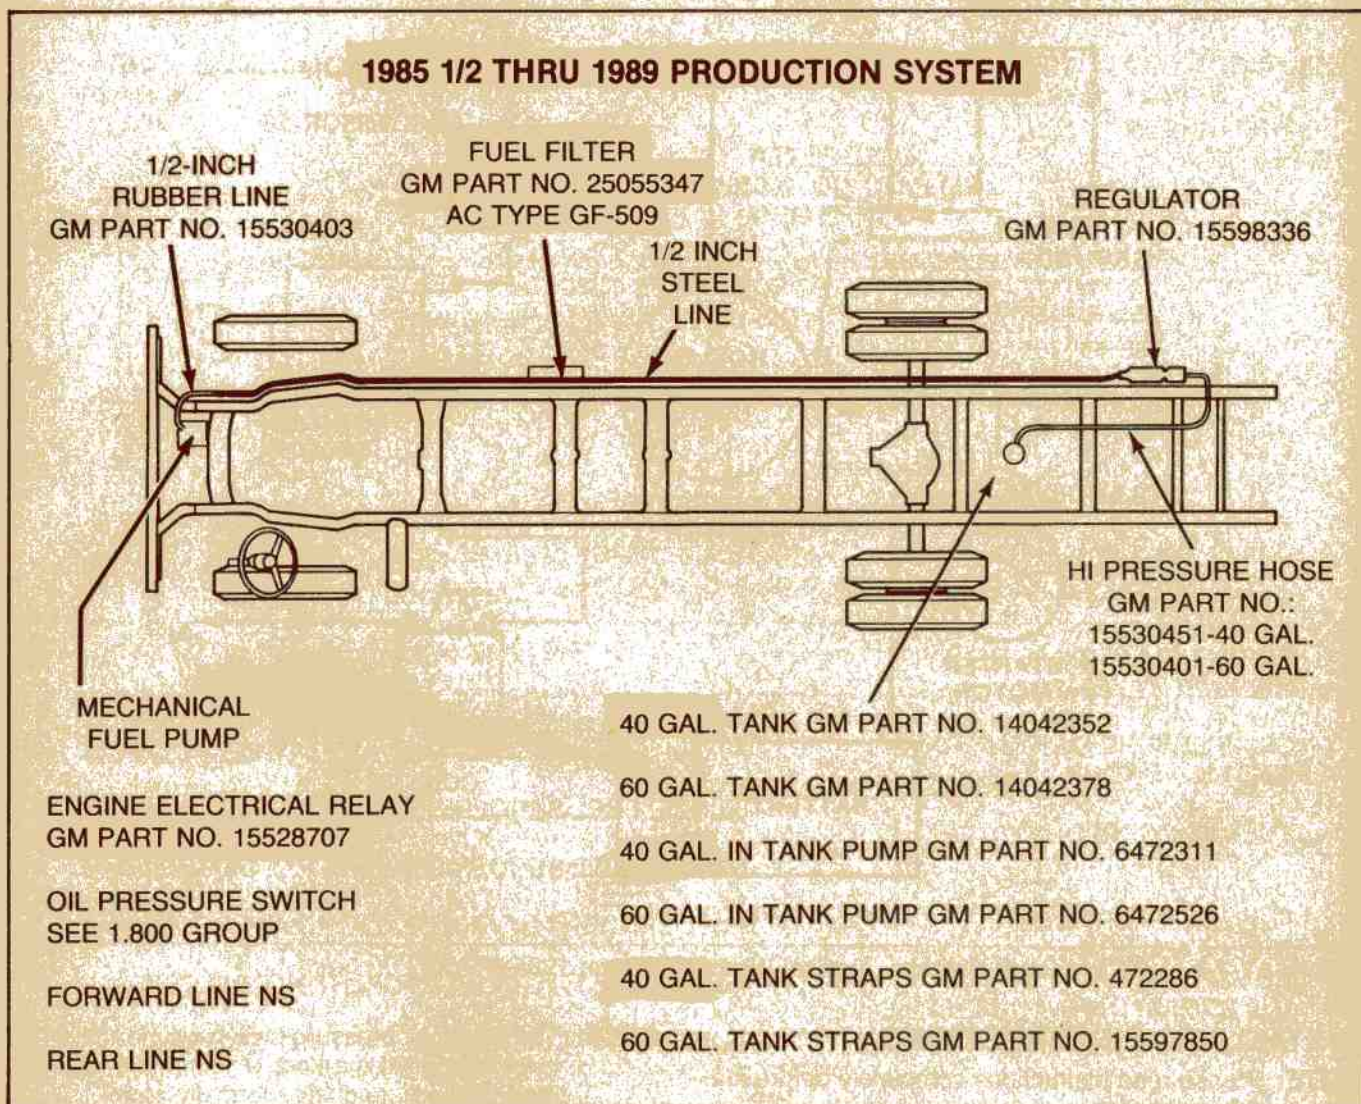
Figure A7-7-5 — 1985 1/2 to 1989 Pressurized Fuel System Components

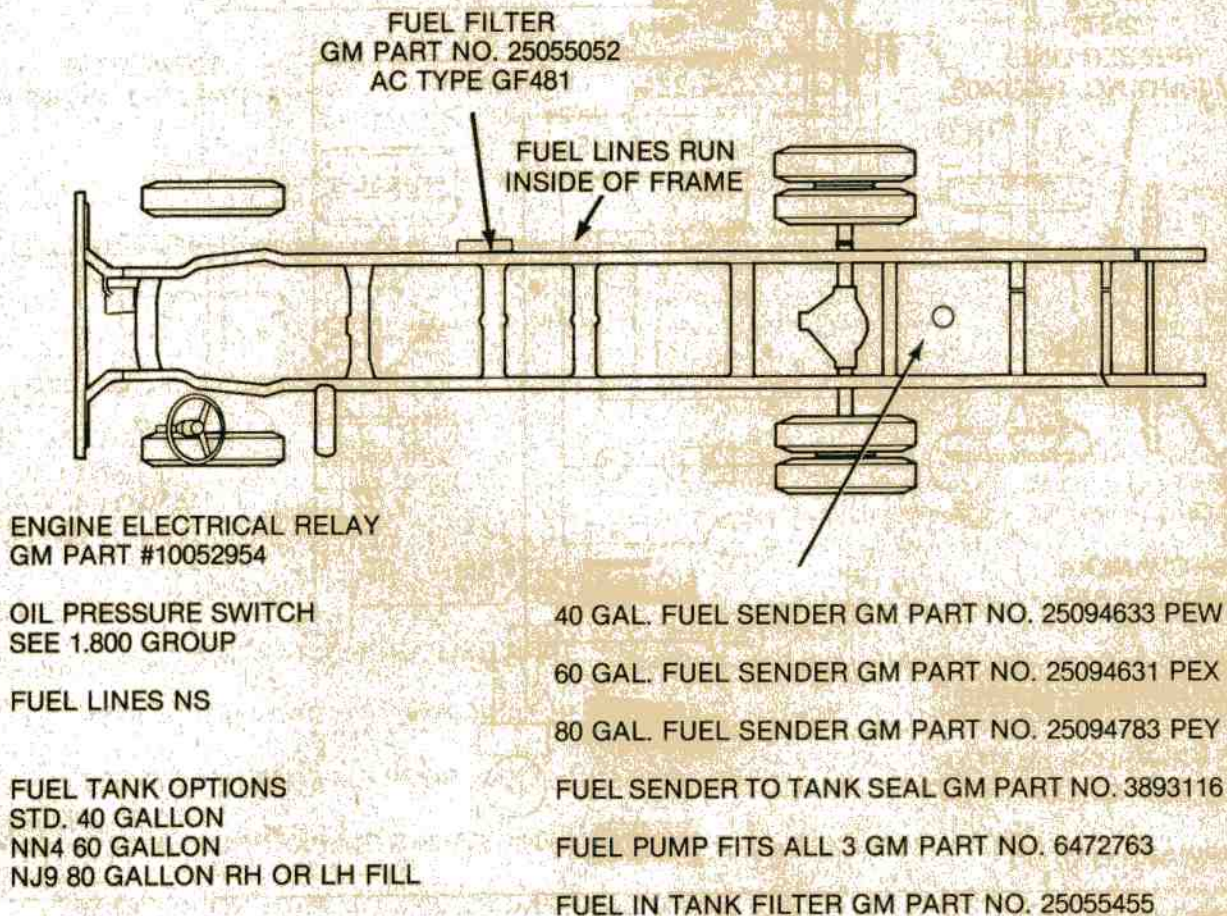
1990 & UP PRODUCTION SYSTEM FUEL INJECTION
