GM Splash Shield Template and Tech Sheet

P-Series Splash Shield RH 15983041

EXHAUST MANIFOLD AND PLUG WIRE FAILURE

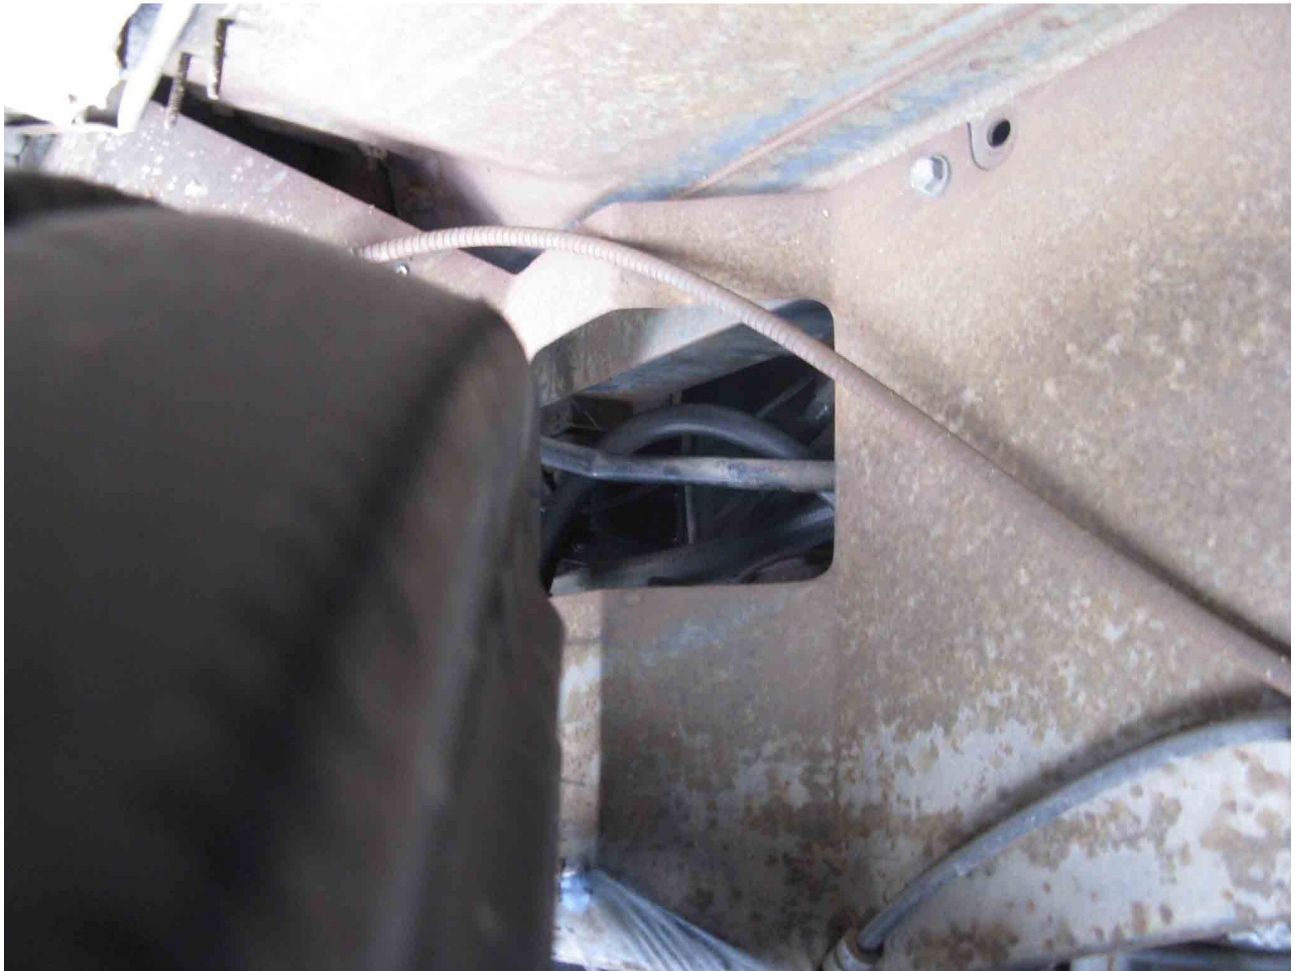
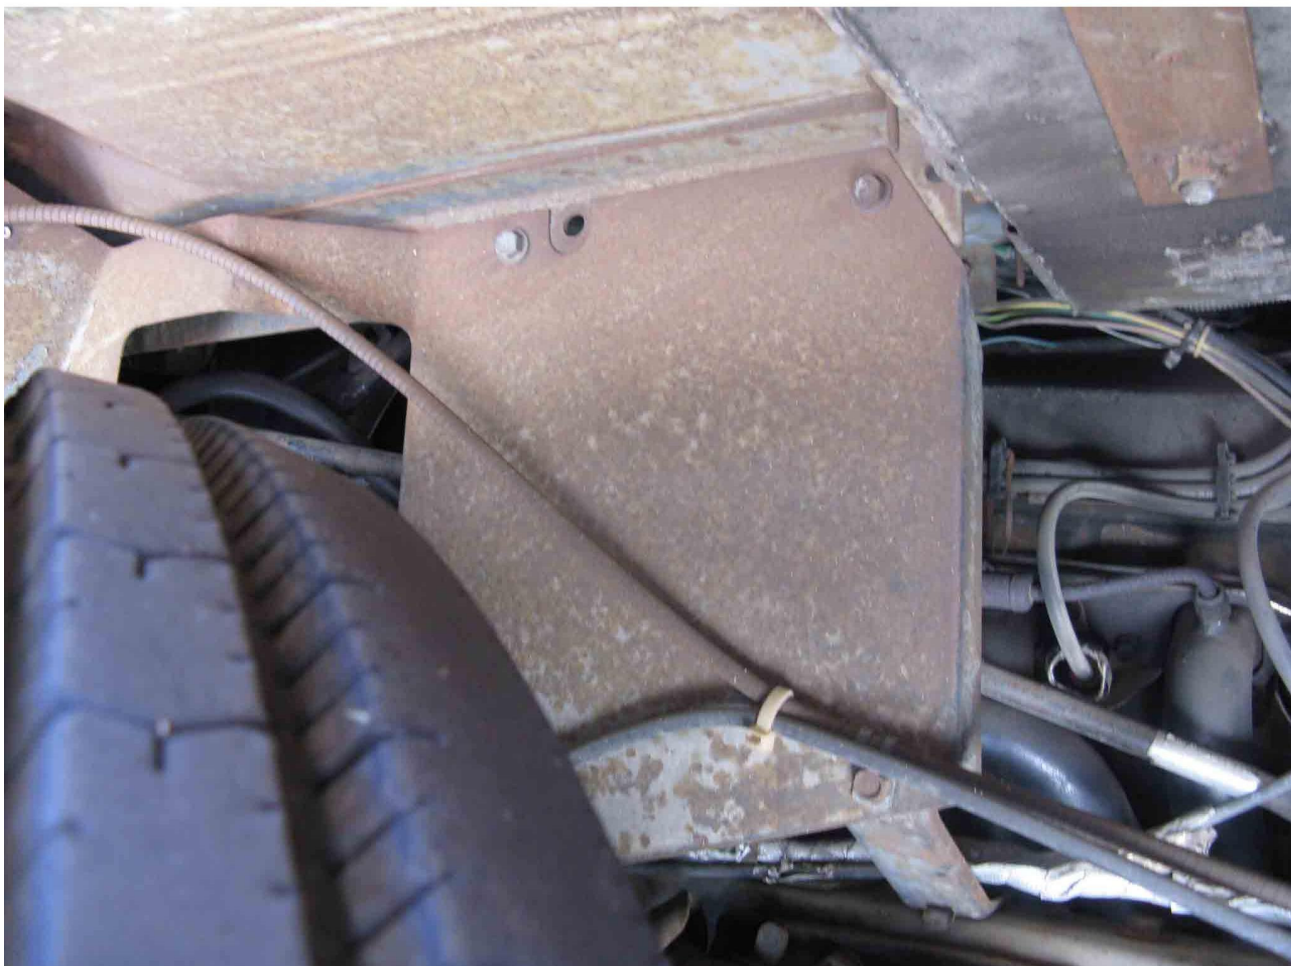
*We've included a view of what the drivers side is
supposed to look - this was installed as original
equipment and should already be on your coach.*
